MEYLE No. 116 050 0029/HD (with 2 stabilizer links)  
MEYLE No. 116 050 0020/HD  
Reference No. 8D0 498 998  
to fit Audi A4, A6 / VW Passat / Skoda Superb

MEYLE No. 116 050 0030/HD (with 2 stabilizer links)  
MEYLE No. 116 050 0021/HD  
Reference No. 4D0 498 998 C  
to fit Audi A8

## Control arm sets, front axle

### Audi A4, A6, A8 / VW Passat / Skoda Superb

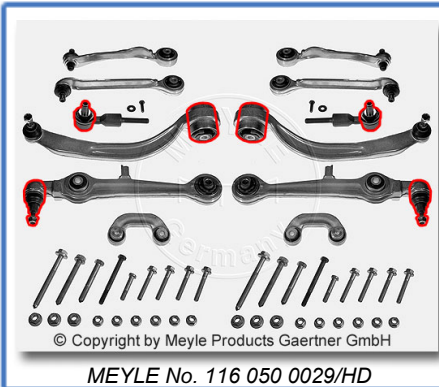
The weight of the vehicle and the dynamic forces lie on the marked ball joint. This is fitted upside-down (fig. 1). Gravity causes the grease to run into the boot and the load-bearing point (arrow) on the joint is without lubrication. The part fails. In a joint project with the **Lufthansa Technik Intercoat GmbH**, MEYLE has developed a new, wear-optimised combination of metal surfaces, shell plastic and lubricant and has applied for a patent.

- Mounting the strut on the control arm

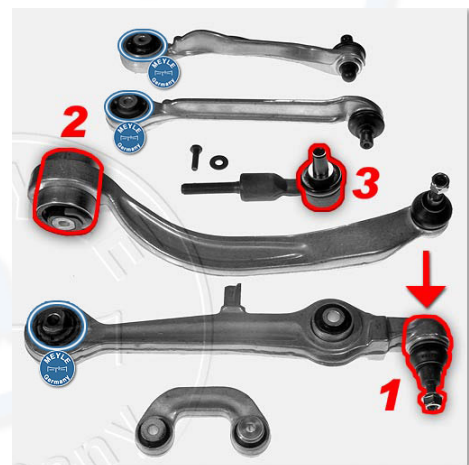
One is aware of this by the squeaking noises coming from the front end when braking. Here MEYLE has developed a solid rubber bushing (fig. 2) designed for a long service life. We can guarantee that you will not notice any effect on driving comfort.

additionally reinforced bushings □ □

- Bushing with hydro filling is prematurely destroyed by high dynamic loads
